Development of a Self-Sustained Wireless Integrated Structural Health Monitoring System for Highway Bridges

Third Quarterly Progress Report

January 15, 2012 through April 14, 2012

The Research Team – University of Maryland with North Carolina State University and URS

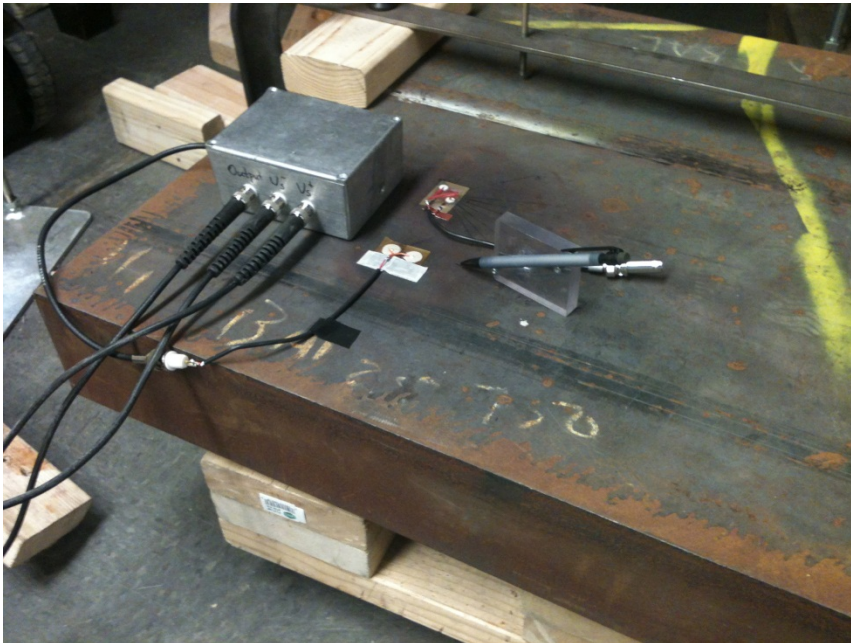
Figure 1. Calibration setup for piezo paint AE sensor

- Designing and testing AE sensor in the lab - Major work conducted in the third quarter includes (1) a new batch of flexible piezoelectric paint was fabricated on March 8, 2012. (2) New design of piezo paint based acoustic emission (AE) sensors were fabricated by an external flexible circuit manufacturer – Tramont (order received in February) and sensor performance was examined in lab in March and April 2012; (3) Fatigue test frame and specimens (including six test steel tube with welded end plate specimens and load frames) were fabricated and delivered in early February. This test frame and specimens will be used for conducting lab characterization test of low-profile piezoelectric paint based AE sensor in the summer of 2012; (4) a new frequency shift based crack source location algorithm is proposed and verified through lab calibration experiments (see Figure 1 below). This near-field AE monitoring strategy is being refined for low-profile piezoelectric paint based AE sensor and has the advantage of improved representation of crack source information. and (5) Fatigue test of a portable setup to simulate fatigue crack propagation (see Figure 2 below) was conducted in January 2012. The setup consists of a steel base plate, two steel bars welded to the base plate and proper weight to simulate the bridge vibration frequency (around 3.4 Hz). Piezoelectric paint sensors have been installed on base plate to monitor any AE signal caused by fatigue crack initiation and propagation; (6) A Labview-based virtual instrument software for data acquisition of AE data was developed but still need improvement including the new frequency shift feature for crack source location.

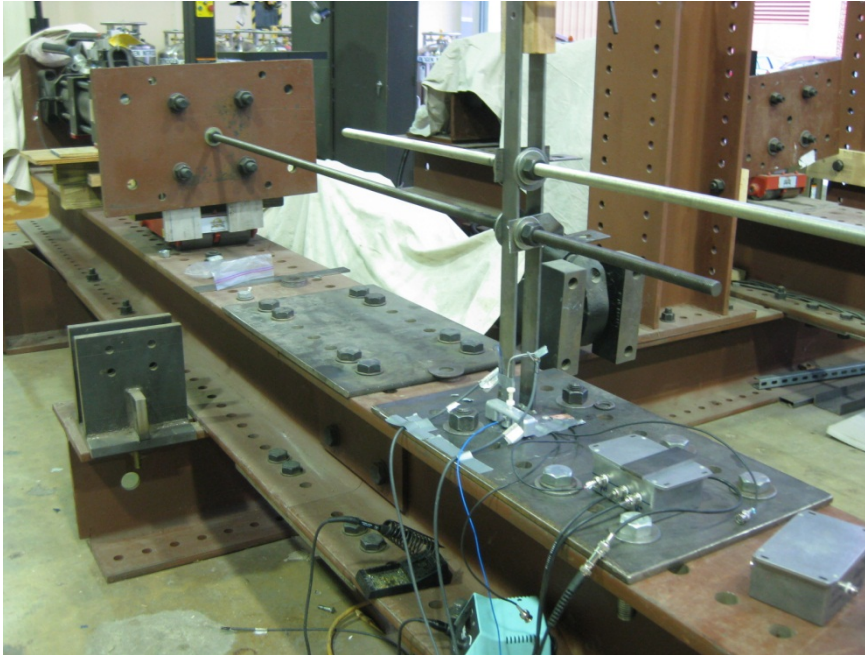
Figure 2. Fatigue test setup for portable fatigue simulation rig

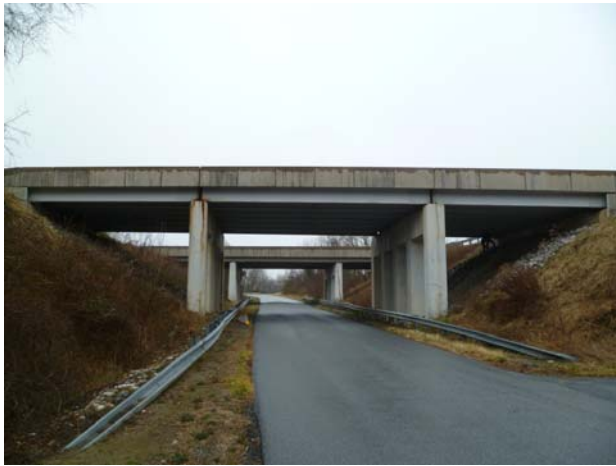
Figure 1. View of the bridge

Bridge Type: Steel I-girder Bridge

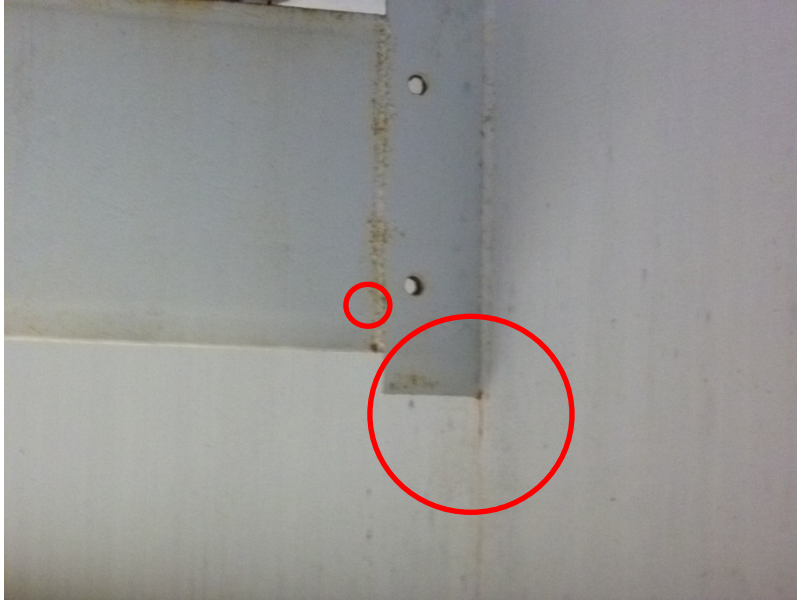
Figure 3. Fatigue crack on girder web location (at the weld intersection of diaphragm and web plate)

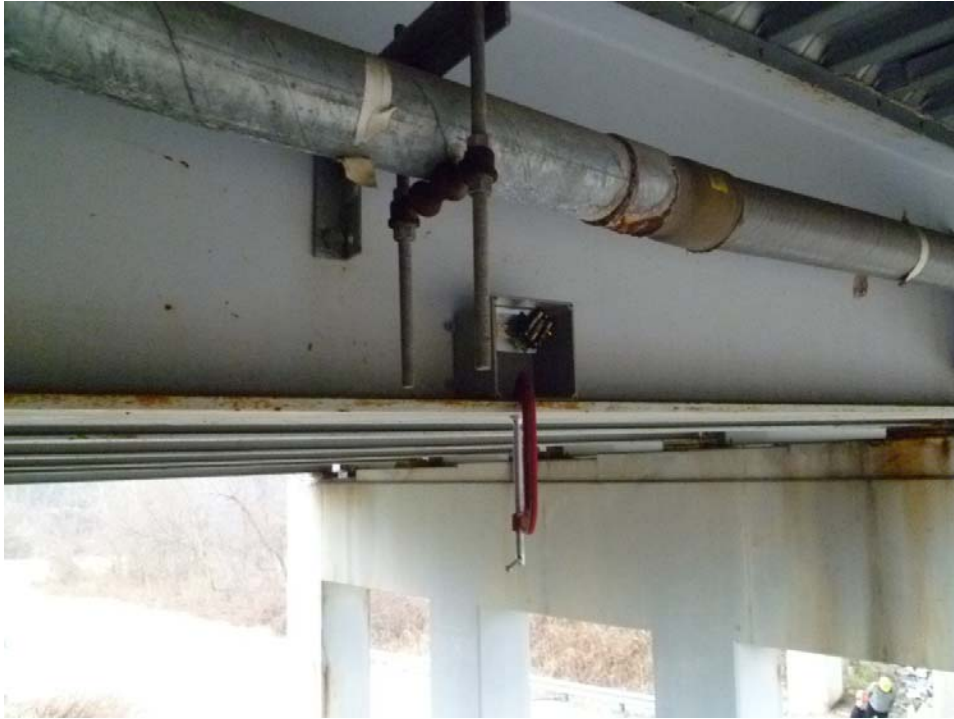
Figure 4. Wireless sensor (measuring acceleration) at south side (about 10 ft from abutment) of the bridge

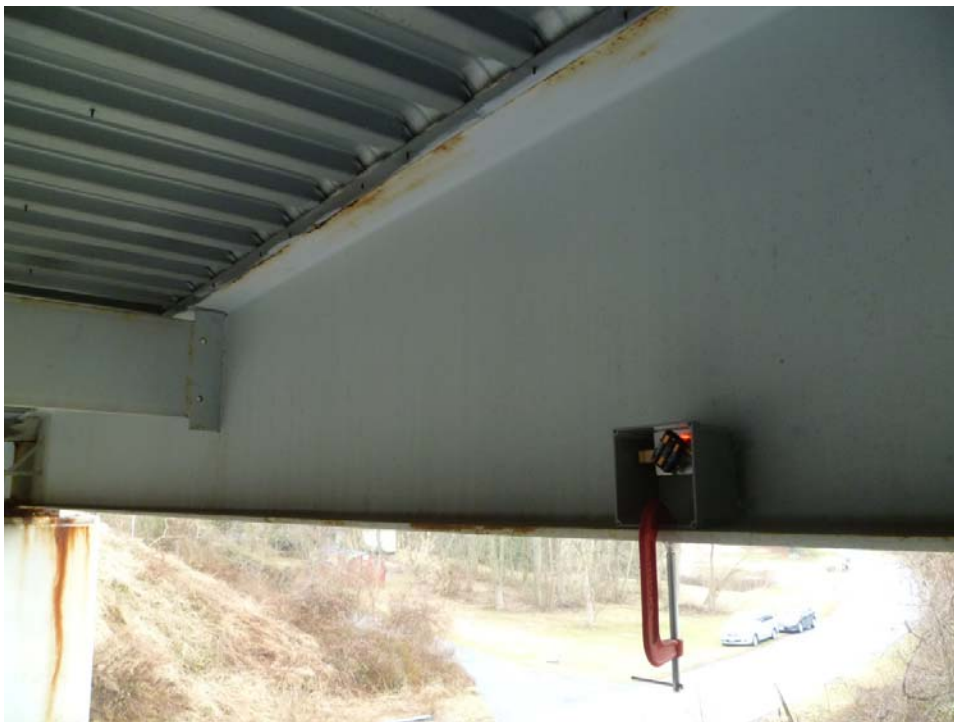
Figure 5. Wireless sensor (measuring acceleration) at north side (about 7 ft from abutment) of the bridge

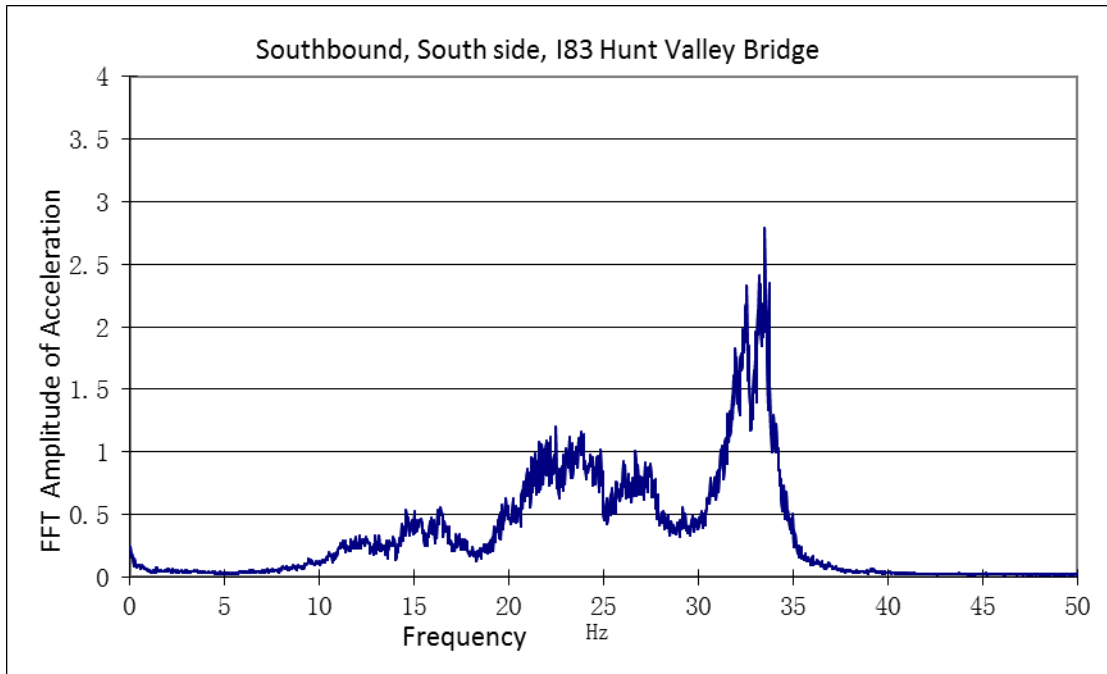
Figure 6. FFT amplitude of measured acceleration at southside of the bridge (average of 10 records, each record has duration of 30 seconds, and sampling rate of 100 Hz)

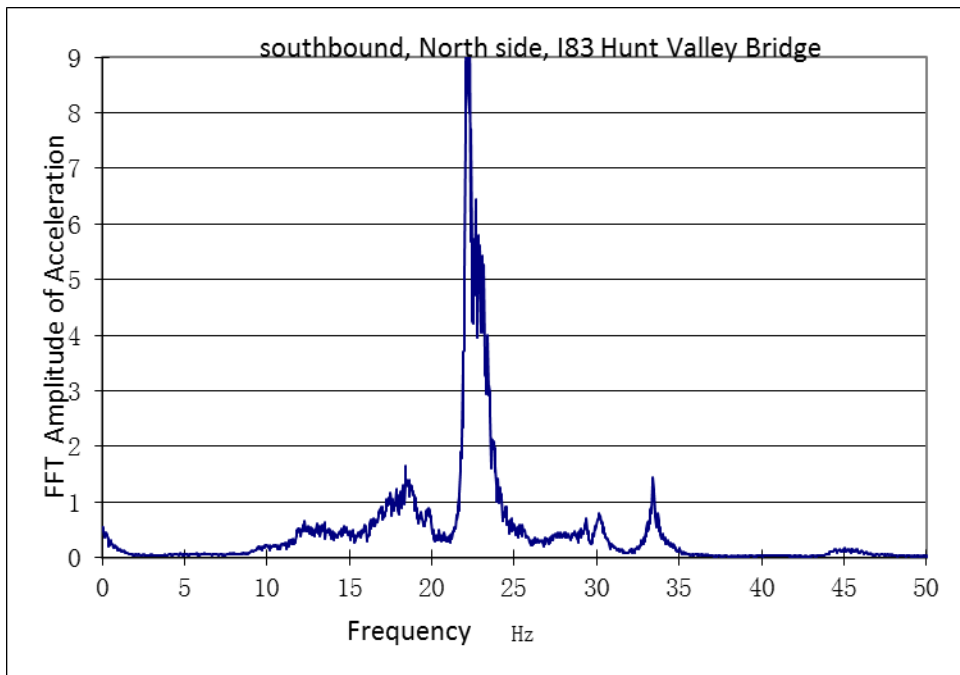
Figure 7. FFT amplitude of measured acceleration at north side of the bridge (average of 10 records, each record has duration of 30 seconds, and sampling rate of 100 Hz)

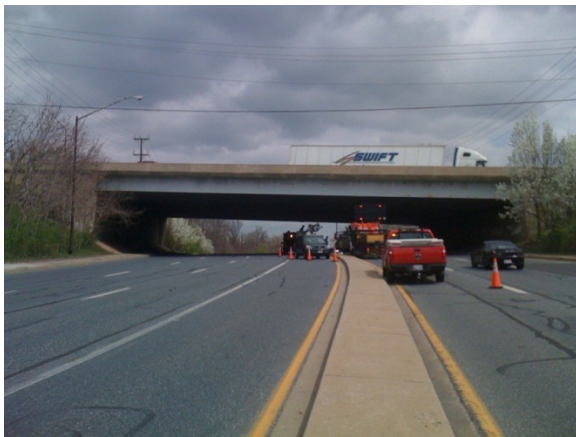
Figure 1. View of the bridge

Bridge Type: Single-span composite steel I-girder bridge (span length = 140 ft.; Figure 1)

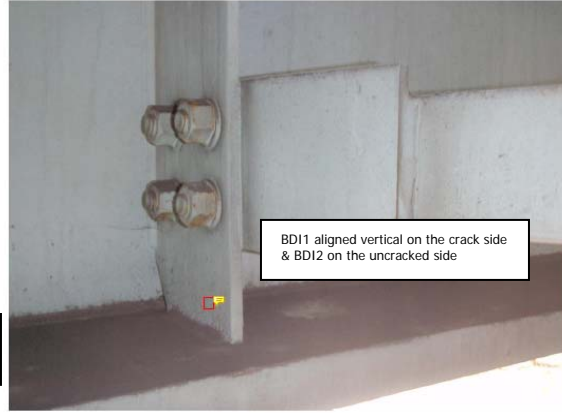
Figure 5. No Sign of Cracking at G3B3D3 (Girder 3 Bay 3 Diaphragm 3) and one

Also shown are Figures 4-7 for cracks on Girders 3 & 4 and their respective sensor locations.

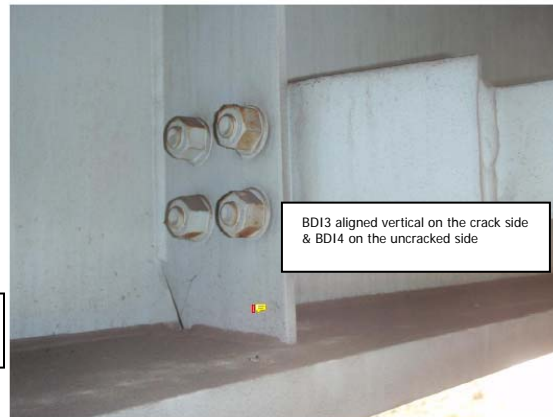
Figure 7. No Sign of Cracking at G4B4D3 (Girder 3 Bay 4 Diaphragm 3) and one sensor

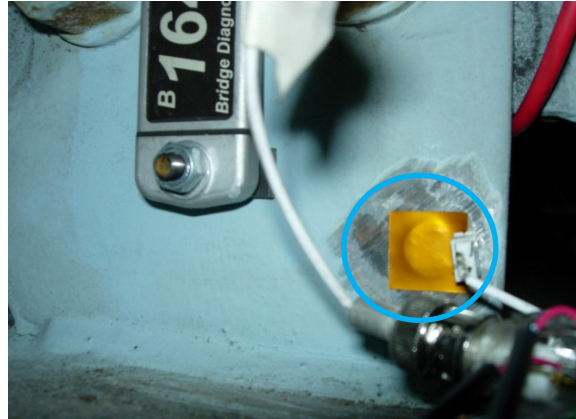
Figure 9. Piezoelectric paint AE sensor (blue circled, for monitoring ambient noise since there is no fatigue crack on this side connection plate)

A total of seven AE sensors were installed on Girder 3 and Girder 4. Three piezoelectric paint AE sensors were installed on Girder 4. Two of the piezoelectric paint AE sensors were placed on the tension side connection plate of Girder 4 where fatigue crack was recently found (see Figure 8) while the third piezoelectric paint AE sensor was placed on the compression side connection plate of Girder 4 to provide ambient noise AE data since there is no active fatigue crack (Figure 9). Figure 10 shows the installation of those AE sensors. Same arrangement is for Girder 3.

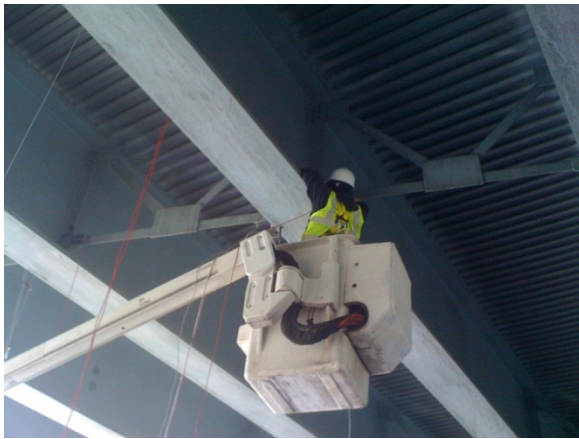
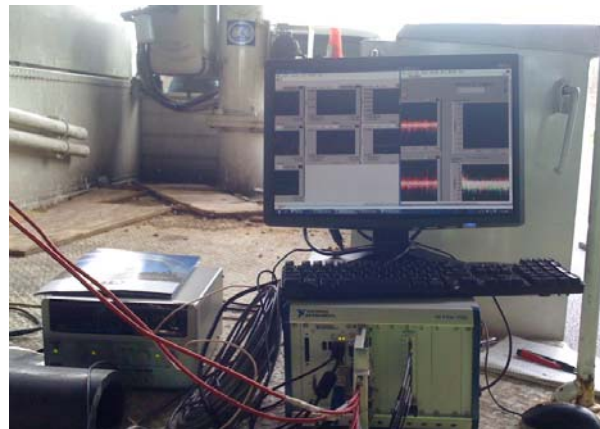
(a)

(b)

Figure 10. (a) Installing AE sensors and wiring; (b) AE data acquisition

Installing AE sensors and wiring took quite some time on March 20 and 21, 2012. The first day (March 19) of field test was spent on surface preparation for installing AE sensors and preparing additional preamplifiers for AE sensors. The second day (March 20) was on installing AE sensors and connecting wires and preamplifier for three AE sensors. During the third day (March 21), most of the time was spent on wire connection and debugging the sensors. Data were collected from all seven AE sensors. Continuous AE monitoring was carried out from approximately 1:10pm to 1:55pm on March 21, 2012. Trigger threshold was set to be 50 mV for each AE sensor channel over this monitoring period, that is, if the AE signal for each channel exceeds 50 mV, data collection would be triggered and a total of 10,000 data points (5 msec.) will be collected for each channel at a sampling rate of 2 MHz. Over this monitoring period, no fatigue-crack-related AE signal is observed. Samples of AE data and their frequency characteristics (by applying FFT on time series data) are shown in Figure 11. This is probably due to the short AE monitoring period (only 45 minutes) during this field test and as such possible AE activities due to fatigue crack growth might be missed. It is recommended in the next field test, a longer monitoring period (e.g., at least three days) will be arranged to collect AE signals related to fatigue crack growth.

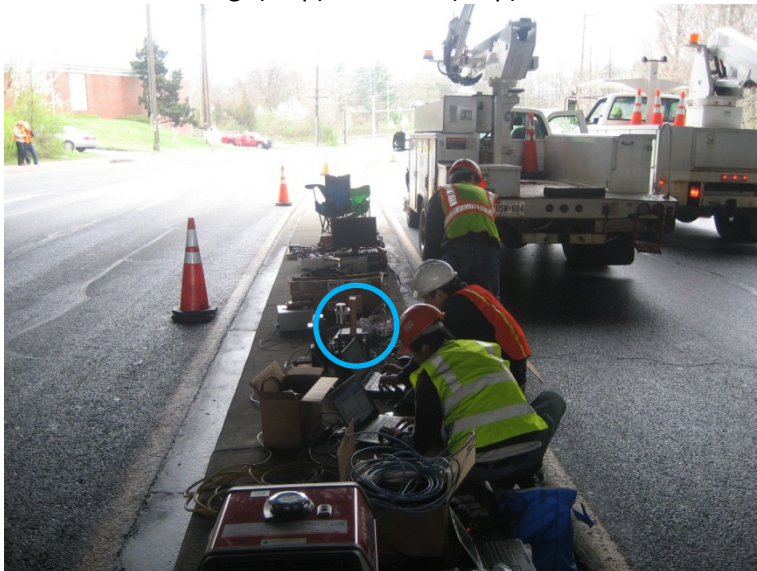
Figure 14. Bridge deflection measurement with ultrasonic distance sensor and laser distance sensor (in blue circle)

Both laser sensor and ultrasonic distance sensors were used to measure the dynamic deflection of the bridge, as shown in Figure 14. Only one laser sensor and one ultrasonic distance sensor were used each time. The data from laser sensor is shown in Figure 15. The measured deflection value from the laser sensor agrees well with the string pot, and its accuracy is also validated by the fundamental frequency indicated by FFT of the laser sensor measured deflection data (see Figure 16). The ultrasonic sensor data had some problems, most likely due to a high sampling rate (20 Hz seems to be too high for ultrasonic distance sensor of this particular model, next time we will lower the sampling rate to 5 Hz, which provides much better accuracy during lab calibration test) and parasitic echo signals from reflecting background such as lower surface of bridge deck (next field test we will install the ultrasonic distance sensor on the girder and let it shoot down on road surface to avoid background noise).

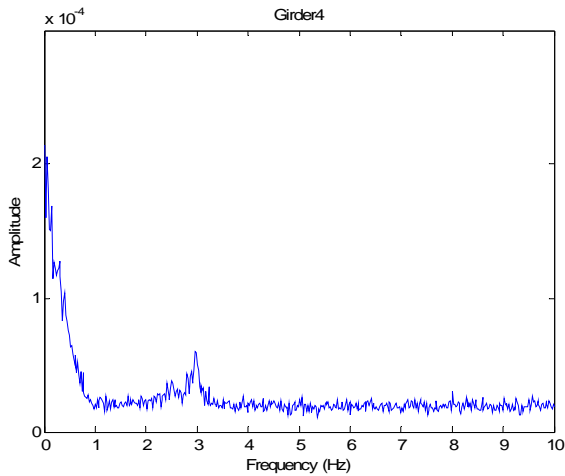
Figure 16. FFT of laser distance sensor
 (note the existence of fundamental frequency of the bridge near 3 Hz)

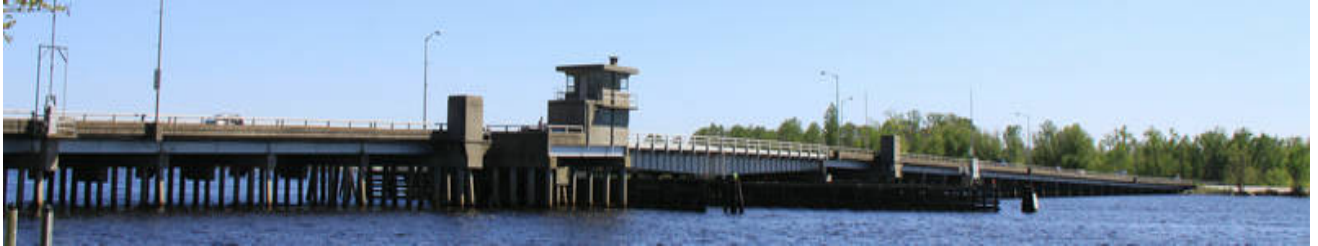
Figure 1 Full scope of the bridge

It can be seen from Figure 1 that the bridge consists of side span and main span, the structural support of the side span is a simply supported girder bridge, which there is no need to be monitored because of its simple stress state. The boundary condition of the main span can change from a simply supported girder bridge to a cantilever girder bridge when the main span is close or open. Considering the complex stress state, the main span will be subjected to be monitored for the dynamic behavior of the bridge. Figure 2 shows the details of the main span.

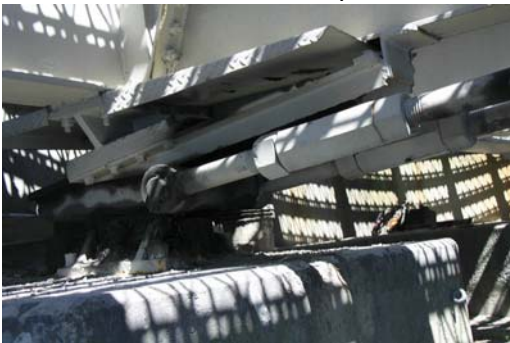
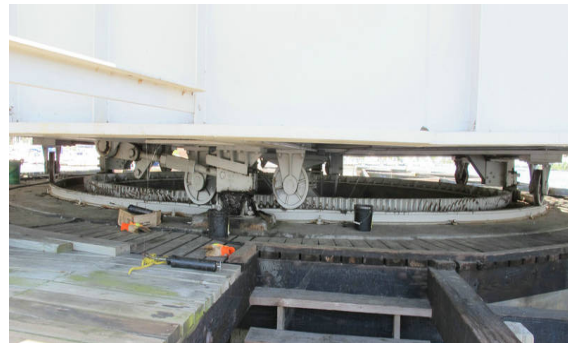
Figure.2 Boundary supports of the main span

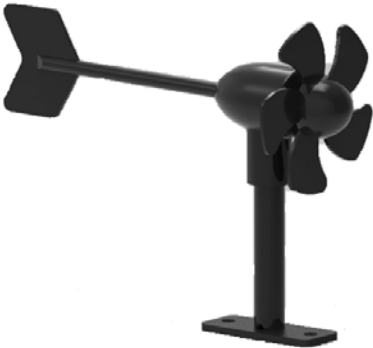
Figure 6 The miniature wind turbine

- Designing and manufacturing wind turbine energy harvester-based on the experimental result of the miniature wind turbine (MWT), which can be used to collect wind energy in the field has been designed and manufactured(Figure 6).
