Development of a Self-Sustained Wireless Integrated Structural  
Health Monitoring System for Highway Bridges

Sixth Quarterly Progress Report

October 15, 2012 through January 14, 2013

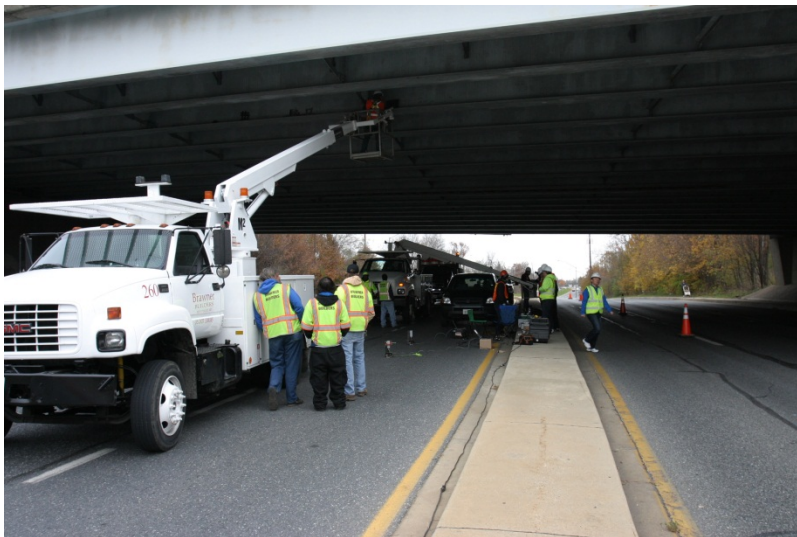
Figure 2. Field test on the I-270/Middlebrook Road Bridge, Maryland

after proper grounding measure was taken the noise went away. Continuous collection of AE signal data was resumed after fixing this noise problem on December 6, 2012. On November 14 and 15, 2012, another comprehensive field test of this steel I-girder bridge was conducted (see Figure 2). Three piezoelectric AE sensors were replaced with new sensor installations, as shown in Figure 3. These AE sensors were checked to ensure they are working during field test. On site integration test with NCSU participation was conducted for November 14, 2012. In addition, laser distance sensor was employed to monitor bridge deflections at a typical sampling rate of 10 Hz remotely with an accuracy of 1 mm and measurement range up to 500 m. A major cause for the fatigue crack is believed to be live load induced stresses in the diaphragm connection welds resulting from differential deflections between adjacent girders. The laser distance sensor operates on the basis of non-contact comparative phase measurements with amplitude modulation, which is much less costly than laser Doppler vibrometry scanner. Sample signals of the laser distance sensors are shown in Figure 4.

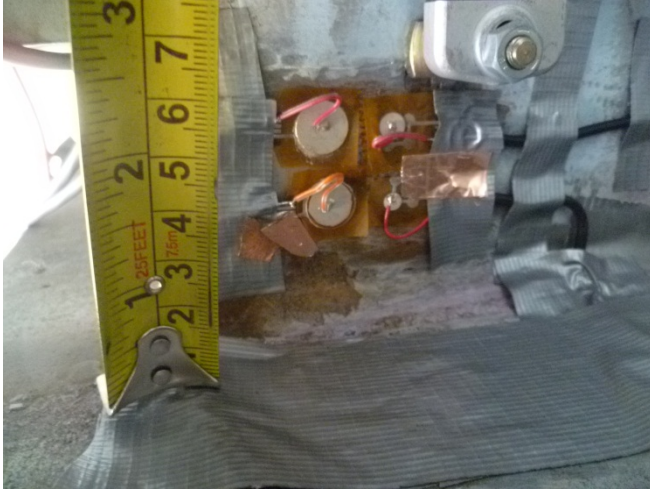
Figure 3. New installation of piezoelectric film AE sensor near existing fatigue crack on connection plate on Girder #3

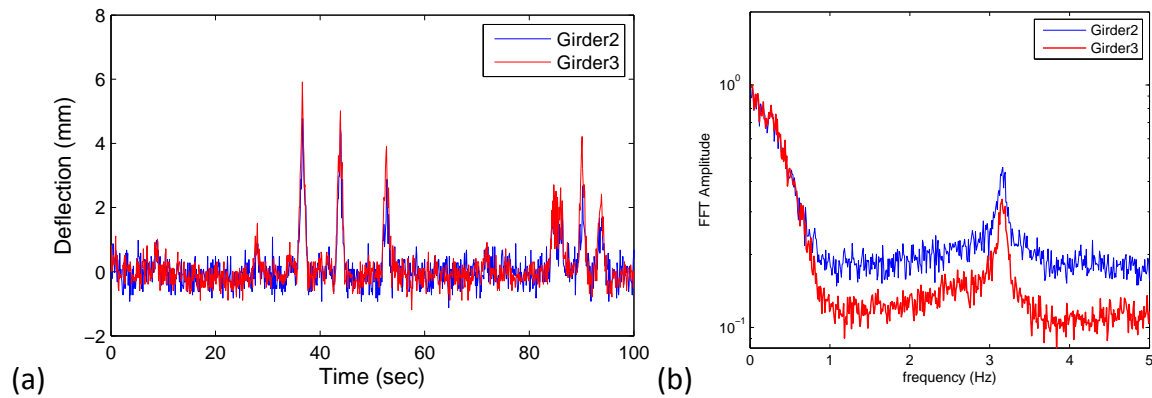
Figure 4. Measured girder deflections: (a) sample time series; (b) FFT spectrum (average of 36 records) (fundamental frequency identified as 3.16 Hz)

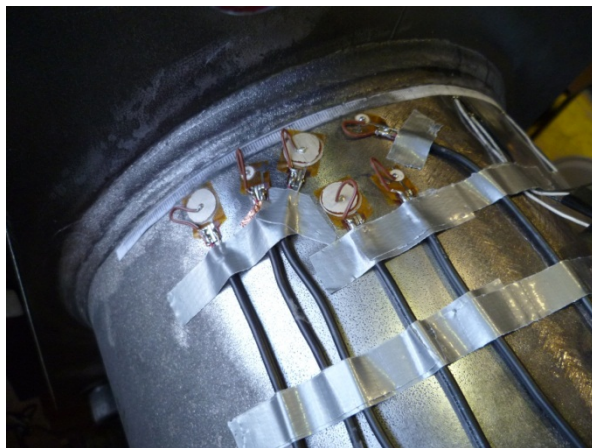
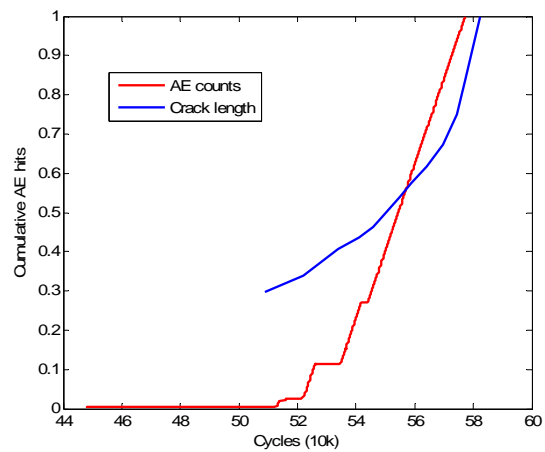
Figure 5. Piezo film AE sensor array (left) and Relation between cumulative AE signal counts (hits) and loading cycles of the fatigue test

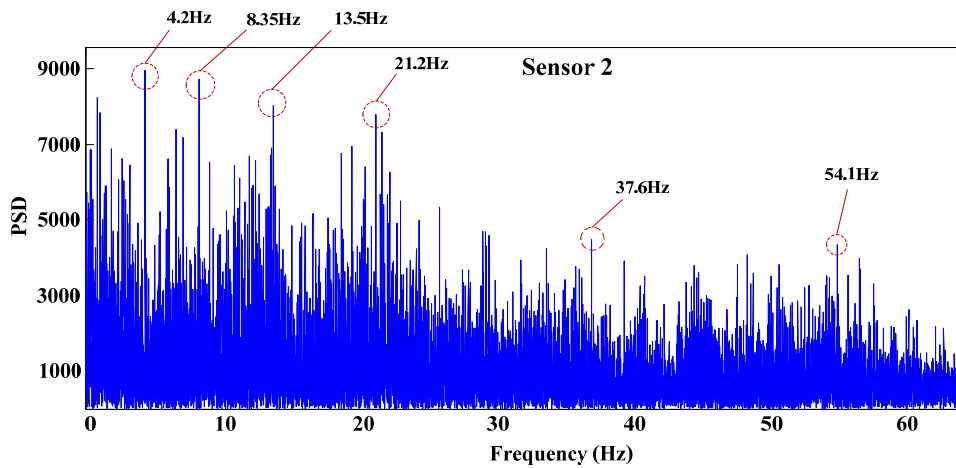
Figure 7 is the test result of Beaufort #25 Bridge by using the WSN. From the figure we can see that the FFT result is not good enough to recognize the resonant frequency of the structure. We just can primarily estimate the natural frequency of the bridge is between 4 Hz to 5Hz.

Figure 7 The results of field test of I-270 Bridge

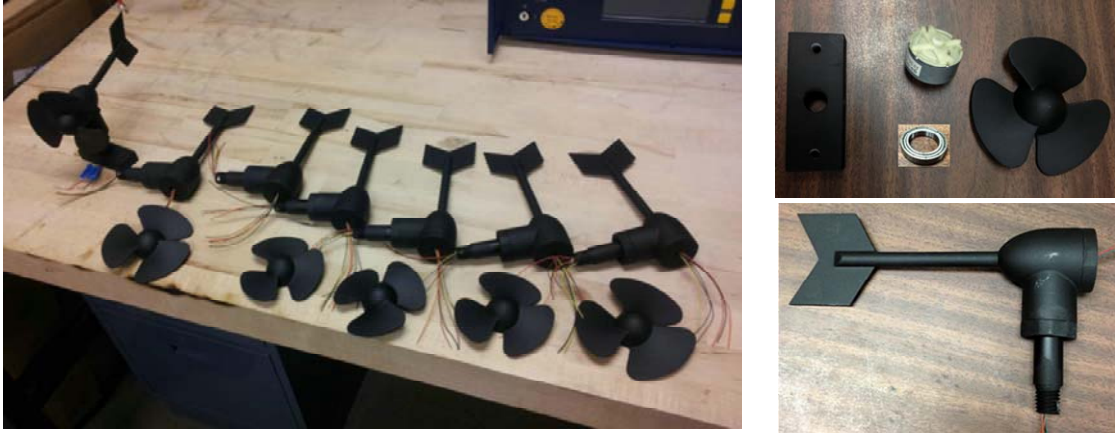
- A total of 16 miniature wind turbines have been manufactured and arrived, which has been designed and tested in our previous work. Figure 8 shows the miniature wind turbine and its components.

Figure 8 The new designed miniature wind turbine
