## **Quarterly Report**

Development of a Self-Sustained Wireless Integrated Structural  
Health Monitoring System for Highway Bridges

Eighth Quarterly Progress Report

April 14, 2013 through July 15, 2013

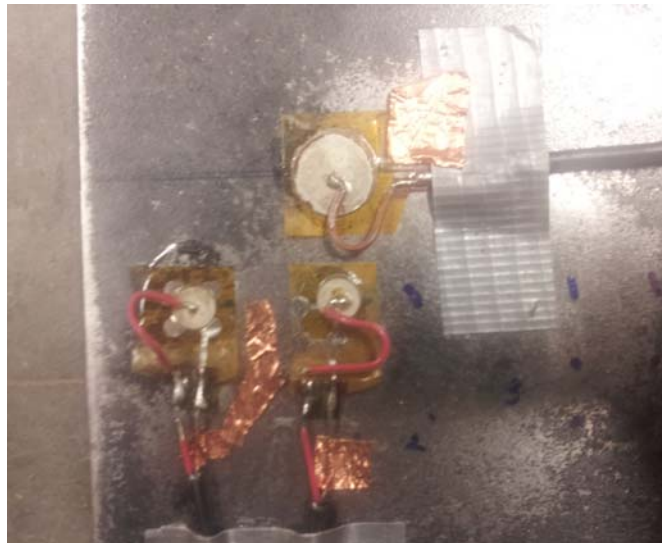
Figure 6. Piezo Sensors

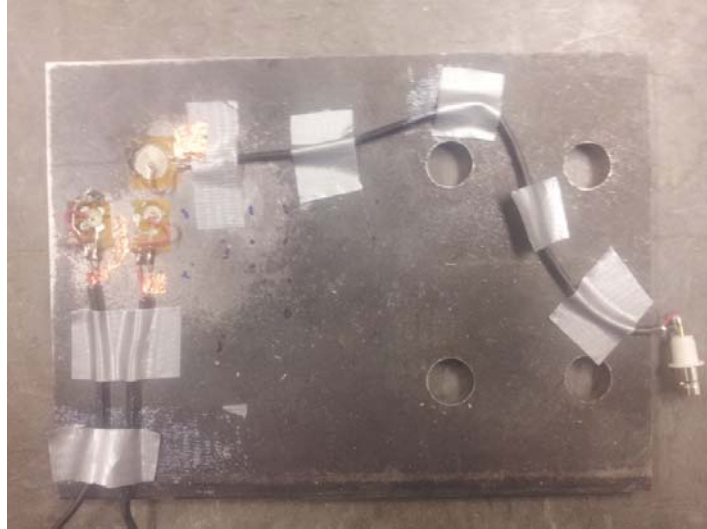
Figure 7. Test Platform
